**2023 NDIA MICHIGAN CHAPTER
GROUND VEHICLE SYSTEMS ENGINEERING
AND TECHNOLOGY SYMPOSIUM
ADVANCED MATERIALS & MANUFACTURING TECHNICAL SESSION
AUGUST 15-17, 2023 - Novi, MICHIGAN**

LIGHT-WEIGHT DRAPABLE ANTI-CORROSION COVERS

¹Transshield, Inc., Elkhart, IN

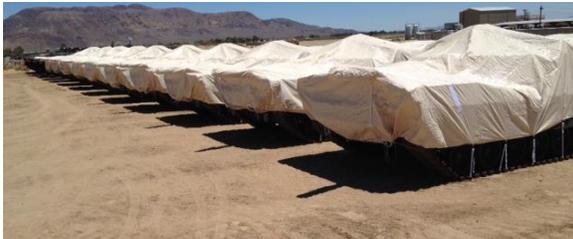
Figure 1: M1A1 tanks protected by a tan XT cover.

As USMC use grew, the U.S. Army started acquiring XT covers. Examples of XT anti-corrosion covers protecting M1A1 Abrams tanks, Strykers and JLTVs are shown in Figures 1, 2 and 3 respectively.

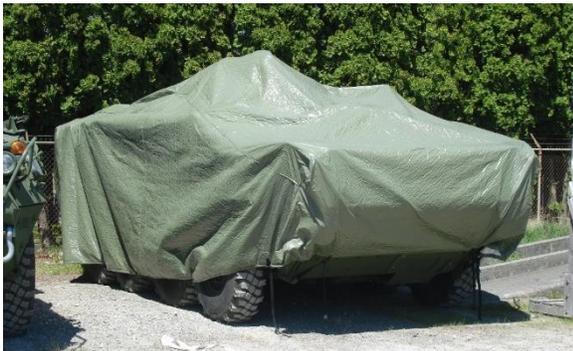
Figure 2: A Stryker protected by a green XT cover.

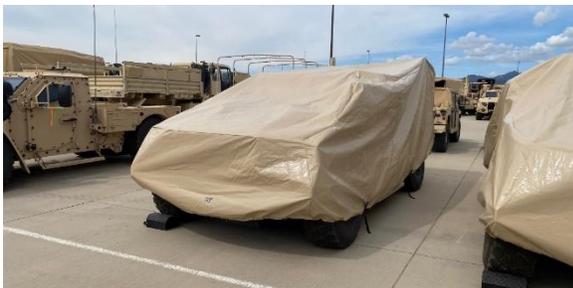
Figure 3: JLTVs protected by a tan XT cover.

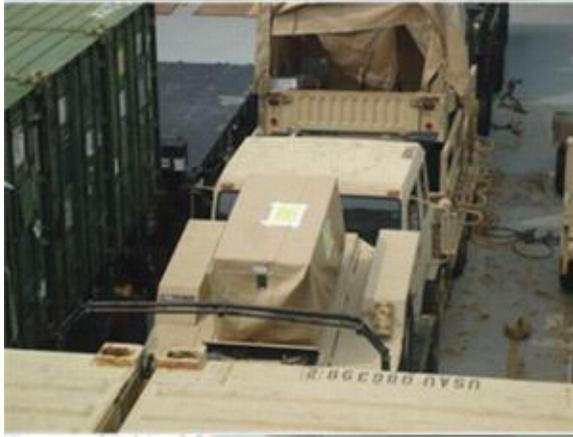
Figure 5: U.S. Army MEP-1040, 10kW 50/60Hz Generator protected by an ArmorDillo cover

The effectiveness of anti-corrosion covers with VCI technology is highlighted by the following example of ground forces equipment being transported across the Pacific Ocean [9]. A test was conducted in 2015 at the request of USARPAC and the 25th Infantry Division. Transshield XT and ArmorDillo anti-corrosion covers were placed on an M997 HMMWV Ambulance and MEP-1040 Generator respectively prior to a voyage from Malaysia to Hawaii on board the U.S. Army Logistic Support Vessel-2, CW3 Harold A. Clinger; Figures 5, 6 and 7 respectively.

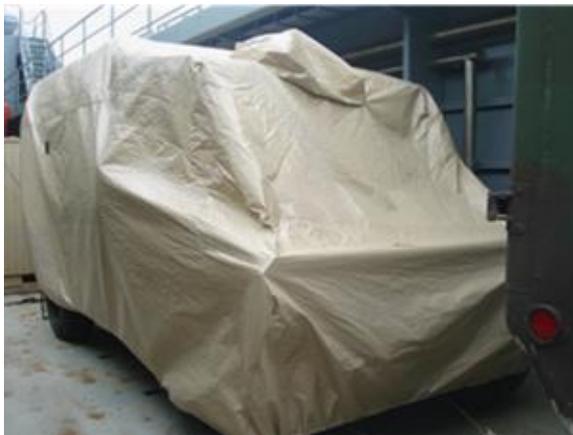
Figure 6: U.S. Army M997 Ambulance HMMWV protected by an XT cover

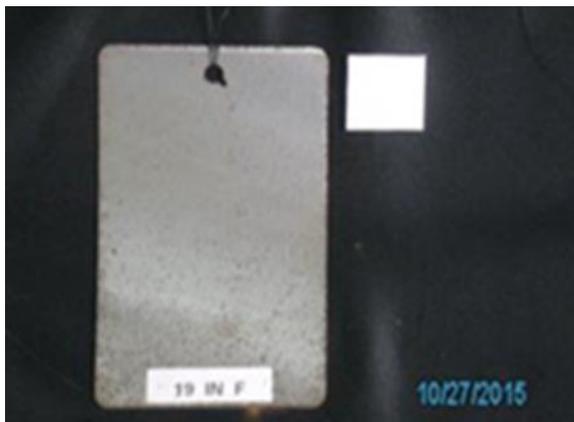
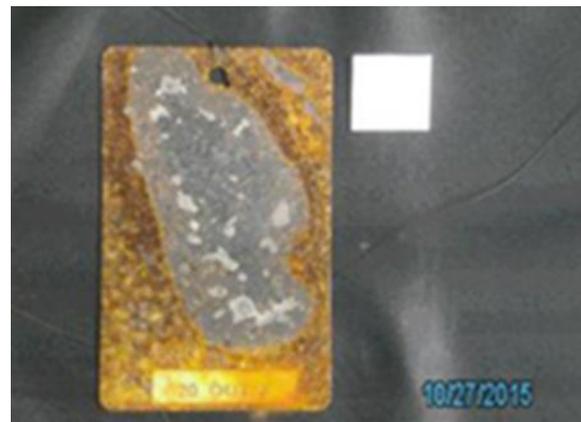
Figure 8.a: Pair A - 19 IN F MEP-1040 Protected

Figure 8.b: Pair A - 20 OUT F Unprotected

Table 1 shows the protection percentage provided to the coupons, and by deduction the MEP-1040 Generator, by the ArmorDillo anti-corrosion cover. All paired coupon

results for the MEP-1040 Generator after the 35-day voyage are shown in Figures 8-9.

Steel Coupon Designation	Inside Protect %	Outside Protect %
MEP-1040 15 TR	76.07	
MEP-1040 16 TL	75.15	
MEP-1040 17 RS	82.24	
MEP-1040 18 LS	93.21	
MEP-1040 19 IN F	97.32	
MEP-1040 20 OUT F		8.76
MEP-1040 21 IN R	98.42	
MEP-1040 22 OUT R		0.00

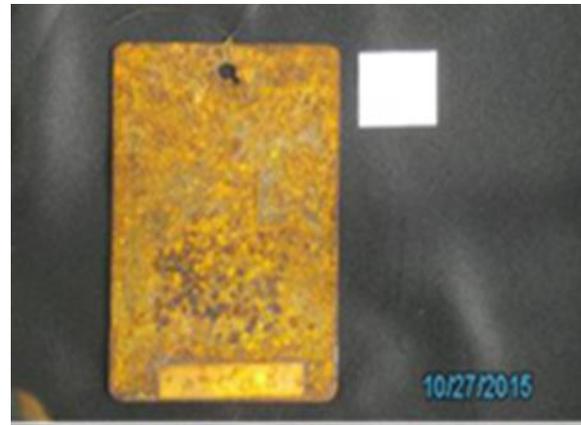
Figure 10.a: Pair A - 06 IN F HV Protected

Figure 10.b: Pair A - 07 OUT F Unprotected

Table 2 shows the protection percentage provided to the coupons, and by deduction the M997 HMMWV, by the Transshield XT anti-corrosion cover while on the Malaysia to Hawaii voyage. All paired coupon results for the M997 HMMWV Ambulance after the 35-day voyage are shown in Figures 10-12.

Coupon 06 IN F did not perform as expected. Examining the percent protection afforded by the Transshield XT anti-corrosion cover, the average was 81.6% when all coupons were included in the calculation. This rises to 94.9% if Coupon 06 IN F is excluded.

It should be noted that an open well deck on an oceangoing ship is an extremely corrosive environment and it is difficult to ascertain what caused Coupon 06 IN F to corrode without 24/7 video surveillance. To properly protect assets, covers should be made of VCI enhanced anti-corrosion cover material, covers should be form-fitting and secured properly to the equipment being protected, and they must be installed correctly.

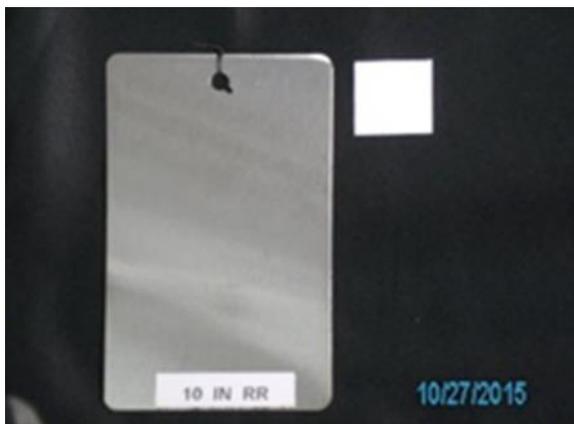
Figure 11.a: Pair C - 10 IN RR HV Protected

Figure 11.b: Pair C - 11 OUT RR Unprotected

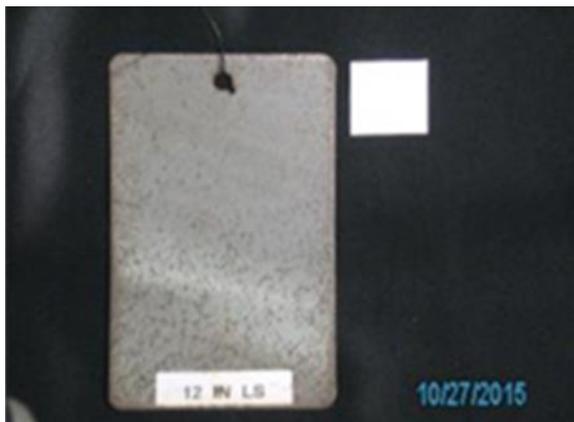
Figure 12.a: Pair D - 12 IN LS HV Protected

Figure 12.b: Pair D - 13 OUT LS Unprotected

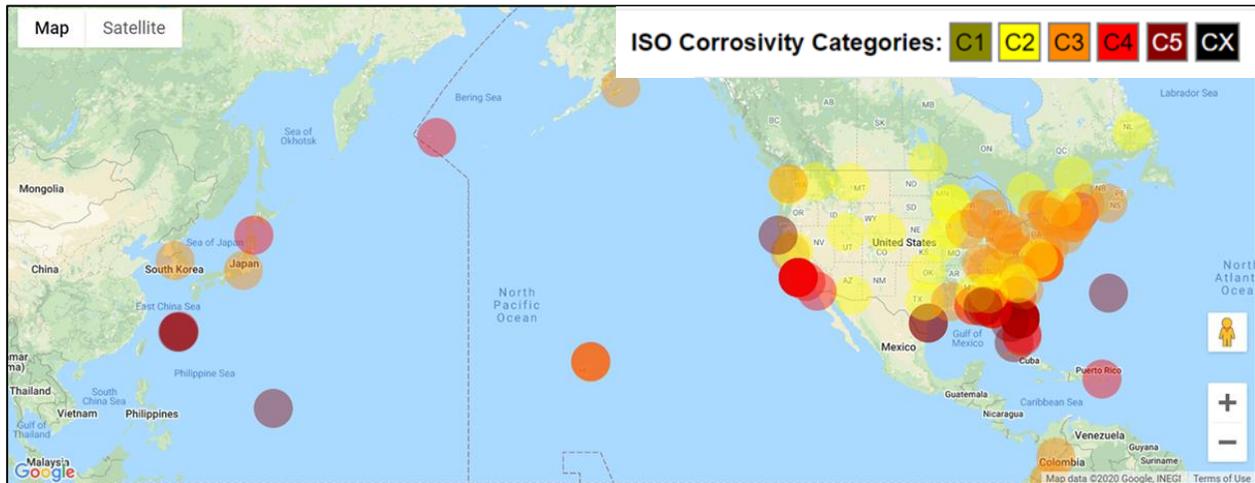
Figure 13: ISO Corrosivity Categories in North America and the Northern Pacific Ocean [13]

The examples presented in this paper for XT and ArmorDillo anti-corrosion covers are associated with highly corrosive areas. The ISO Corrosivity Categories for North American and the northern Pacific Ocean are shown in Figure 13. The ISO Corrosivity

Categories for the USARPAC and the 25th Infantry Division assessment on board the U.S. Army Logistic Support Vessel-2, CW3 Harold A. Clinger are at an ISO Corrosivity Category of C3 or higher.

While USMC ground vehicles may operate in highly corrosive environments, not all U.S. Army and USMC ground vehicles operate or are stored in those environments. Significant portions of the mid-west have an ISO Corrosivity Category of C2.

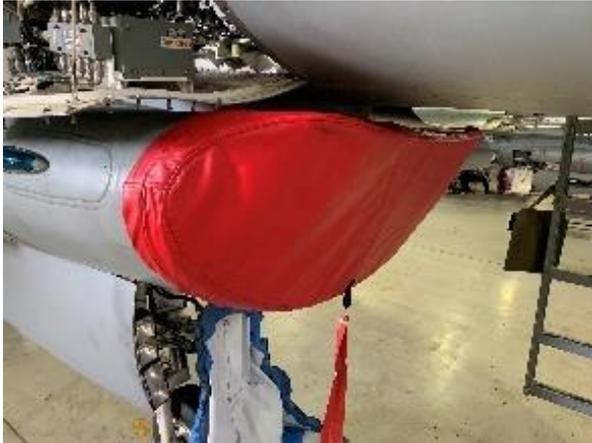
Figure 16: An ArmorDillo cover protecting an F-16's engine inlet from FOD.

ArmorDillo anti-corrosion covers designed to protect an F-16’s engine inlet from FOD and an Apache main rotor and M-TADS from

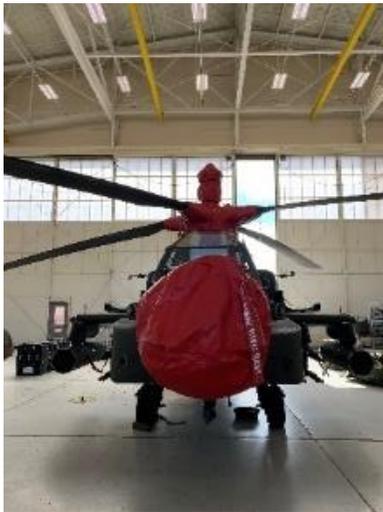
Figure 17: An ArmorDillo cover protecting an Apache rotor and M-TADS from corrosion and FOD.

corrosion and FOD are shown in Figures 16 and 17 respectively.
