**2019 NDIA GROUND VEHICLE SYSTEMS ENGINEERING AND TECHNOLOGY  
SYMPOSIUM  
MATERIALS & ADDITIVE MANUFACTURING TECHNICAL SESSION  
AUGUST 13-15, 2019 - NOVI, MICHIGAN**

**IMPROVE LIP SEAL PERFORMANCE AND INCREASE SAND  
RESISTANCE WITH A LOW-COST GRAPHITE SHAFT COATING**

**ABSTRACT**

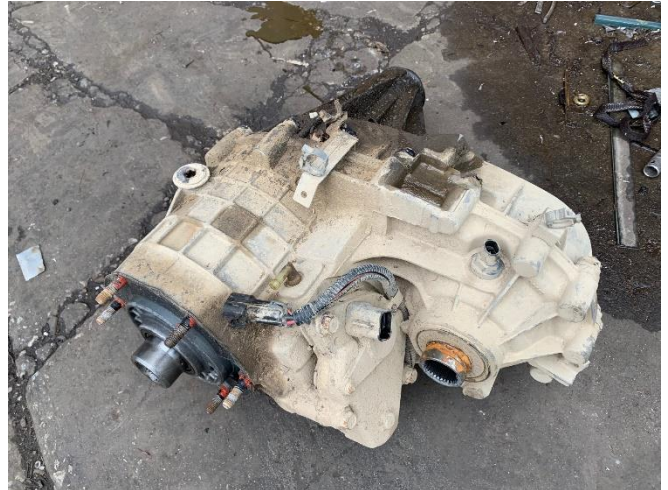
**Fig. 1: Power transmission unit scrapped after seal failure**

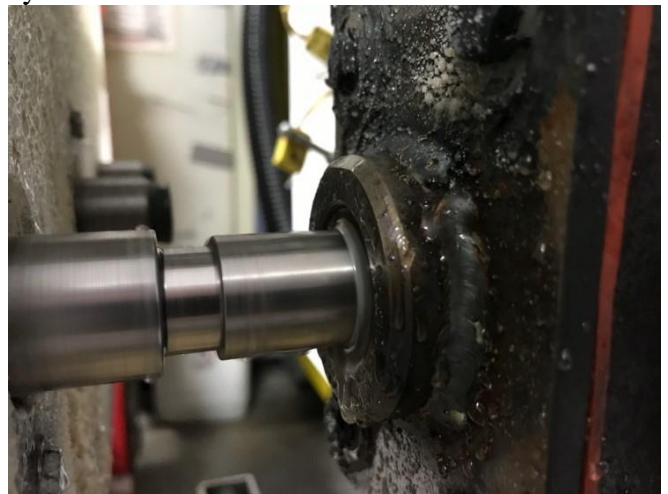
Figure 2a shows milky lubricant which has been emulsified with water near and at the seal to shaft interface during testing vacuum and pressure cycles.

**Fig. 2a: White ring around seal signifies water and oil mixing**

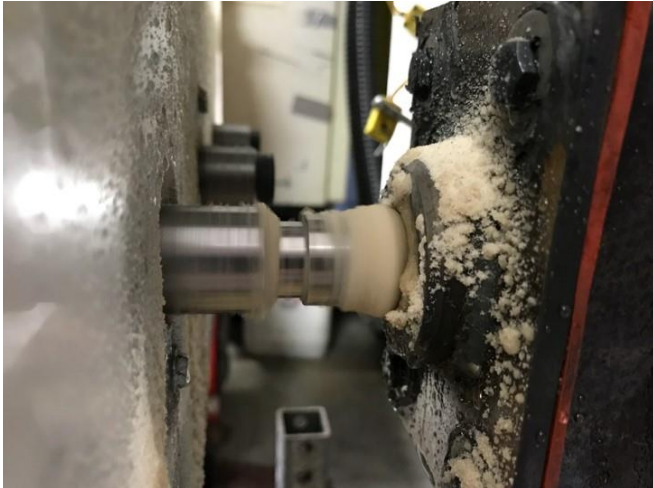
Lubricant leaks detrimentally entrap dust and sand to the fragile seal-shaft interface areas. Figure 2b

shows an example of leaked lubricant collecting sand at and probably under the seal. This process grinds sand particles to finer sizes and increases the likelihood of gear case penetration of abrasive bodies.

**Fig. 2b: Darker shaded sand shows that seal is leaking with uncoated shaft**

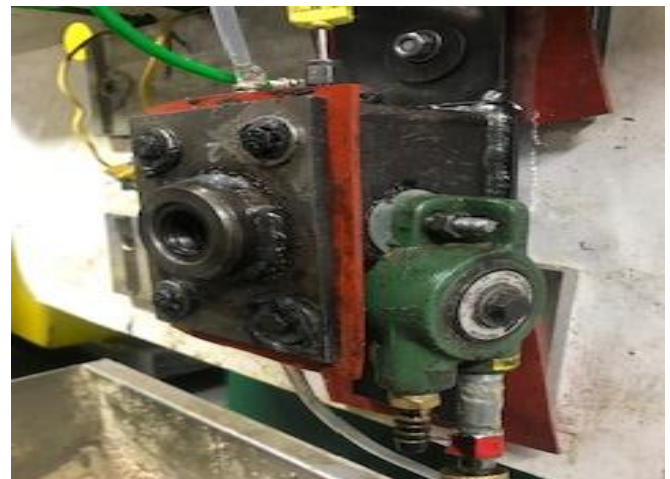
**Fig. 6: Seal Test Chamber- heat, cold, pressure, vacuum, vibration, sand, water conditions controlled**

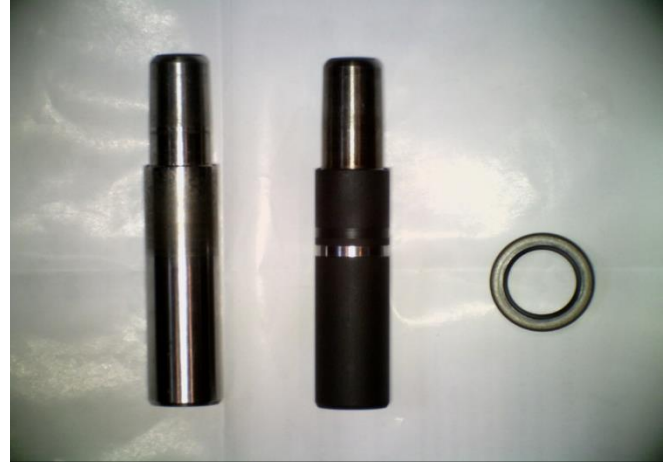
Steel spindles of .875” OD were machined and runout was checked and normalized during all tests. As machined, the ground spindles had surface profile of Ra = 7.6 uin. The coated spindles had a 4-mil thickness (0.008” diametric increase) of AAGC applied the length of the spindle so multiple tests could be done on each.

**Fig. 8: Uncoated and coated spindles next to .875” SZ seal**

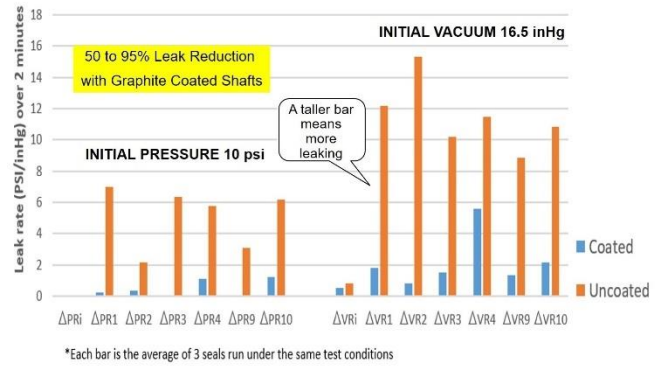
Figures 9a and 9b show that spindles with AAGC Seal Seats had much lower leak rates under pressure and vacuum conditions than uncoated shafts. Taller bars mean higher leak rates. AAGC Seal Seats made a remarkable improvement in this study.

**Fig. 9a: 2-minute vacuum/pressure drop results for runs Without Vibration**

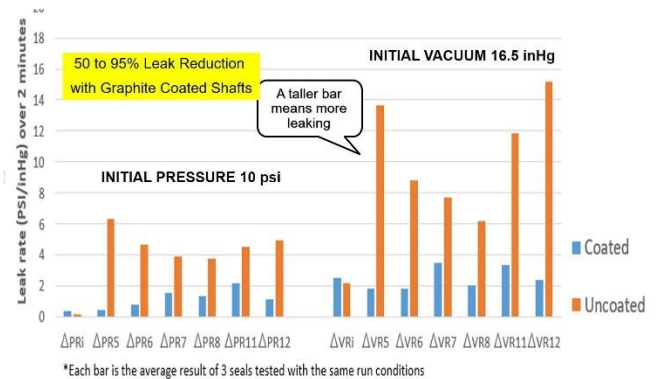
**Fig. 9b: 2 minute vacuum/pressure drop results for runs With Vibration**

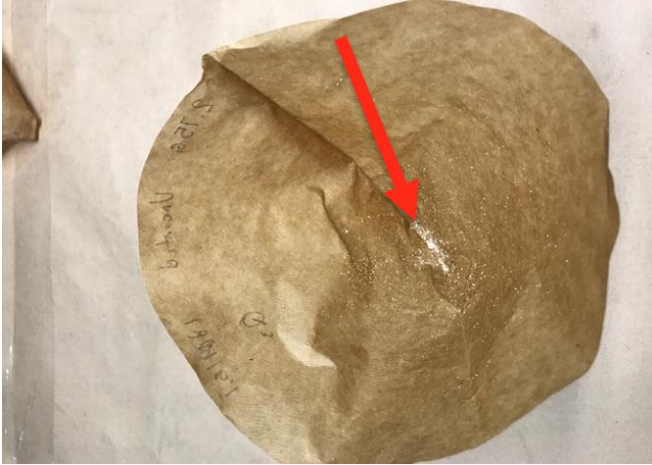
Figures 10a and 10b show the amount of sand which was collected inside the seal and in the oil after Run R2 for the uncoated and AAGC coated shafts respectively. R2 results were typical of the other runs and were arbitrarily chosen for presentation here. The red arrow points to white sand that penetrated the seal on the uncoated spindle.

**Fig. 10a: Uncoated shaft – sand gets in**

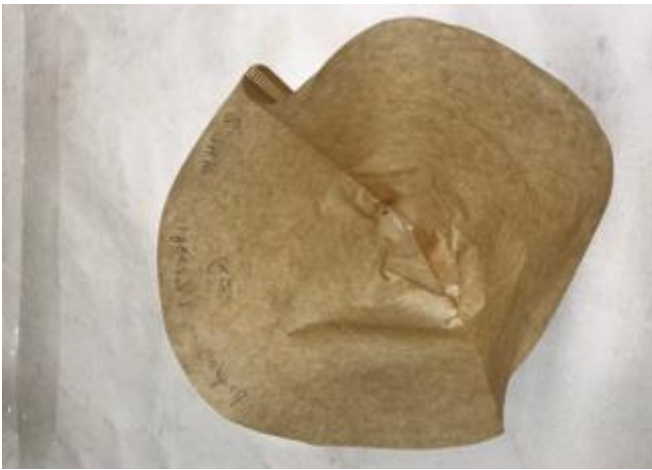
**Fig. 10b: Coated shaft – sand stays out**

The coated spindle prevented all but a few grains from getting past the seal.

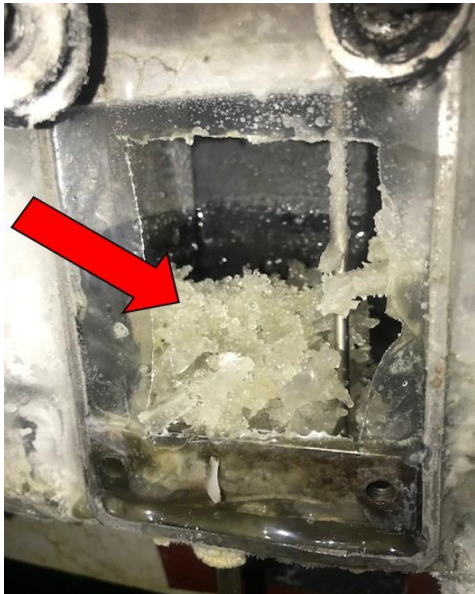
Figures 12a and 12b photos shows order of magnitude change in water penetration and formation of ice in the test chamber after R12 for an uncoated shaft and a AAGC Seal Seal shaft respectively.

**Fig. 11a: Box filled with long ice crystals after uncoated shaft test (R12)**

Dry Ice was packed around the test chamber to simulate cold environment for runs R9-R12. The cooling power was limited. During tests, oil temperature was directly measured to be nominally 0 °F.

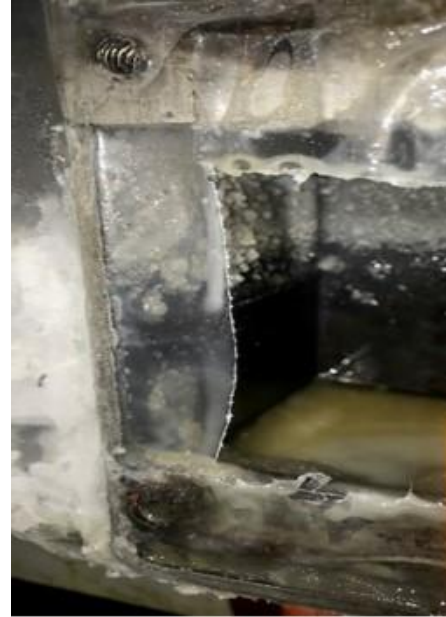
**Fig. 11b: Box chamber had minimal ice slush after coated shaft test (R12)**
