**2014 NDIA GROUND VEHICLE SYSTEMS ENGINEERING AND TECHNOLOGY  
SYMPOSIUM  
MODELING & SIMULATION, TESTING AND VALIDATION (MSTV) TECHNICAL SESSION  
AUGUST 12-14, 2014 - NOVI, MICHIGAN**

**NEW TECHNOLOGIES FOR MILITARY TRACK BUSHING  
ACCELERATED TESTING AND EVALUATION**

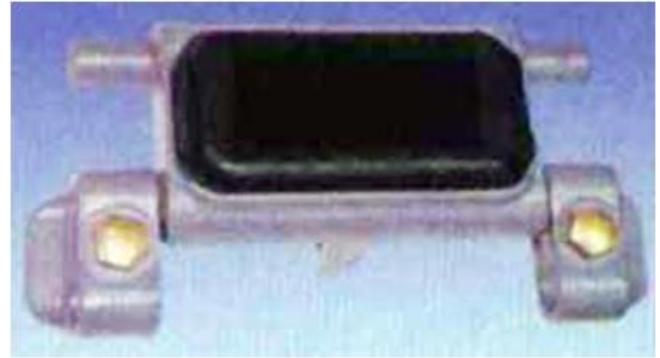
**Figure 2:** T150 Track.

The T130 Bushing, used for compound qualification, is the bushing originally used in the T130 Track system on the M113A3 Armored Personnel Carrier (APC). It is single pin, drive-on-shoe designed track with a 3/2 lattice as shown in Figure 1<sup>2</sup>. This track system has been replaced by the T150 track system on the M113A3 APC, which is a double pin, drive-on-end connector designed track. The T150 shoe is shown in Figure 2.

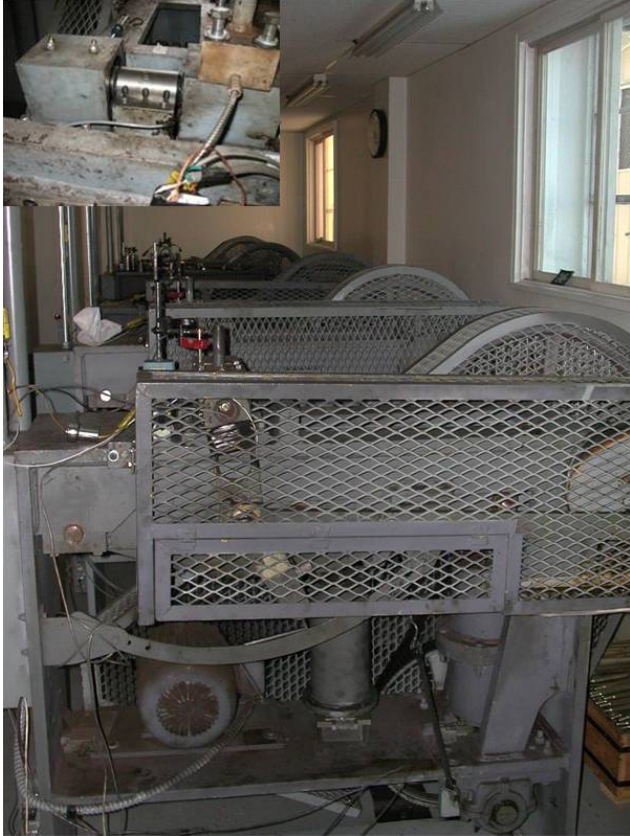
**Figure 3:** MIL-DTL-11891 Bushing Test Machine.

As mentioned previously, the MIL-DTL-11891 is based on the bushing of a single pin track system. Figure 3 shows the test machines used to test to this specification and the insert shows the test bore (see Figure 1) in the machine. Figure 4 shows the type of failure or failure mode of the T130 bushings on this test machine. The image shows an elastomer failure and not a bonding failure. Bonding failures are also experienced by this test however that type of failure will not be addressed in this paper since it is a manufacturing/quality control issue.

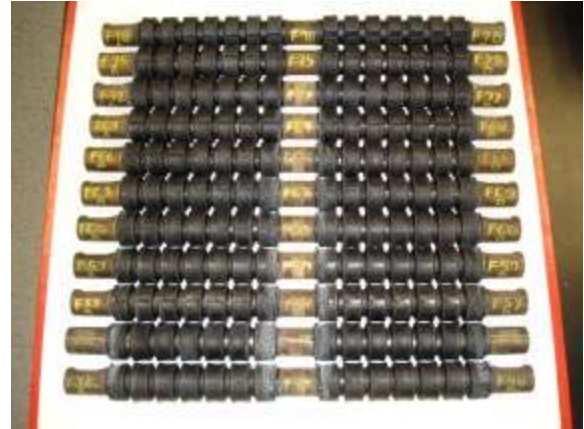
**Figure 5:** Progression of Bushing Failures (Top new bushings, bottom worn bushings, 250 mile increments between samples)

In order to monitor and document the progression and failure mode of a double pin track, T158LL shoes were dissected at mileage intervals during a M1 Abrams Track test. Figure 5 shows the progression of bushing failures in 250 mile increments. As can be seen in this figure the bushing failures progress from the outside of the shoe toward the inside (Bushing 1, 7, 8, and 14). Figure 6 shows an individual bushing failure mode. As can be seen, the failure mode here not only has a radial component but also has a torsional component.

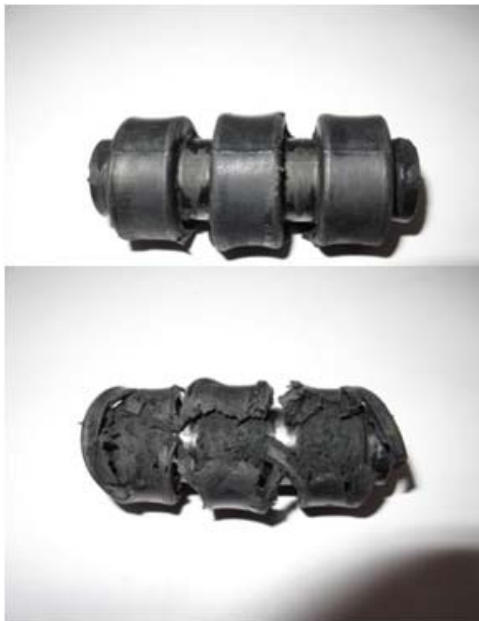
**Figure 4:** MIL-DTL-11891 T130 Bushing Failure

As can be seen in Figure 4, the elastomer in this bushing has failed in a relatively small area in a purely radial direction. The side opposite the radial load application looks almost new as can be seen in the view shown in the top of the figure.

Comparing the failure mode between in-field T158LL bushing and those from a Full Pitch Machine test clearly shows a better comparison than that found in the MIL-DTL-11891 test shown in Figure 4. Figure 8 shows a comparison

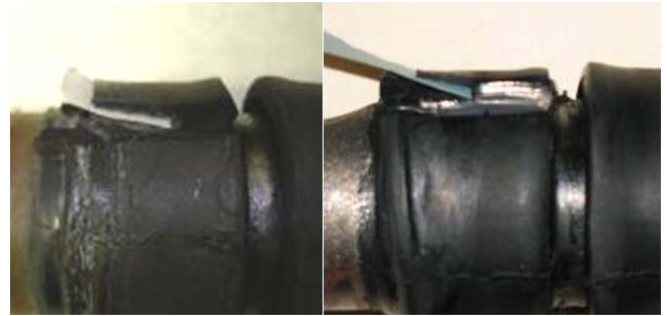
**Figure 8: Crack Initiation from Field Test (left) and Lab Test (right)**

of the edge effect crack initiation between the field and lab test samples. As can be seen, the two compare closely.

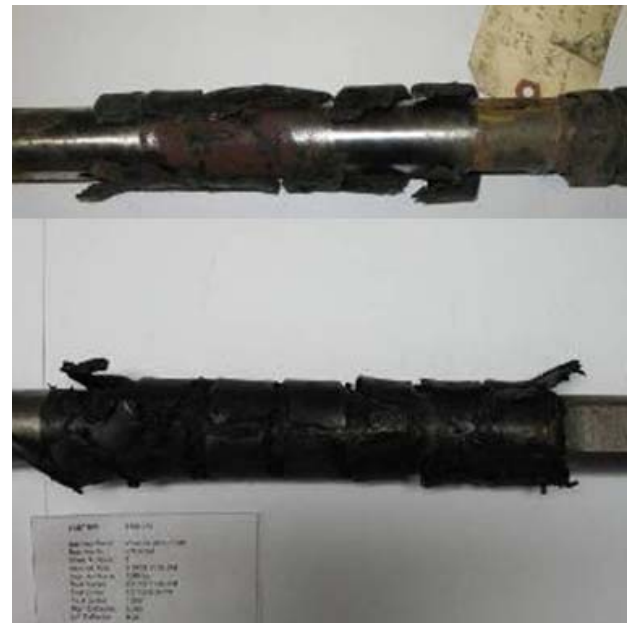
**Figure 9: Radial and Torsional Failure from Field (top) and Lab Test (bottom)**

Figure 9 shows the final failure of the bushings from the field test (top) and the lab test (bottom) of the T158 track. Although difficult to see in the photographs, the 2 failures both experience the same mode. Both have a radial crushed zone of similar size and a torsional tearing of the bushing around the circumference of the pin. The field tested pin shows a polishing area not seen in the lab test most probably due to sand and dirt getting into the bore. Rust is also seen in the field tested part due to the migration of water into the bore as the bushings fail from the outboard sides of the track blocks.

Similar samples of pulverized rubber were also seen in both samples indicating a similar failure mode.

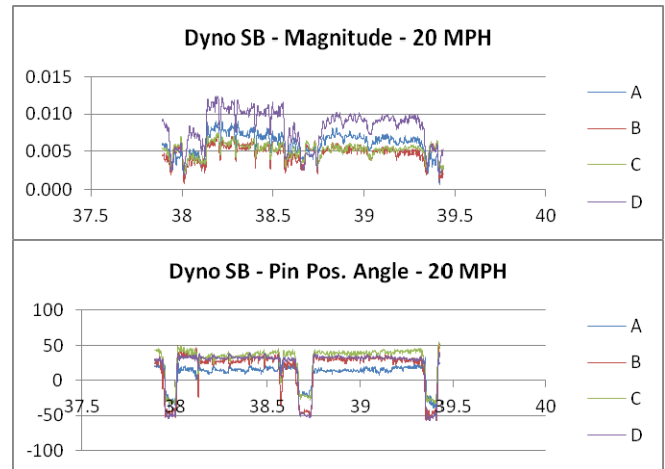
**Figure 11:** Magnitude and Deflection of the Track Pin Laguna Paved, South Bound 20 mph

Once installed on the vehicle, the driver proceeded to run all of the Paved, Secondary, Hilly and Cross Country courses at YPG that make up the TRADOC Opmode. Figure 11 shows a section of data recorded on the Paved Course. Shown is one revolution of the track. As can be seen in the figure, the signal starts at the Sprocket, traverses under the 6 Bradley road wheels, through the idler and across the support rollers and finally re-engaging the sprocket. Trace A is the outboard most transducer and Trace D is the inboard most transducer. Magnitude of the displacement in inches is shown on the top plot and Angle of the pin deflection in degrees is shown in the bottom plot.

The data shows a much more complex bushing load case with more radial and torsional inputs than the simple 1 to 4 ratio of previous tests. Pulling data from a single point in time reveals what the pin is actually doing relative to the track blocks. Figure 12 shows a point in time when the shoe is engaged in the sprocket. The deflection data shows that pin bending does exist in the double pin track design as some theorized.

Another theory that was shown to be true was that the radial loading of the pin occurs in a larger vector than was reflected in the laboratory tests as can be seen in the lower trace of Figure 11.
