YEAS2017 NDIA GROUND VEHICLE SYSTEMS ENGINEERING AND TECHNOLOGY SYMPOSIUM
MODELING & SIMULATION, TESTING AND VALIDATION (MSTV) TECHNICAL SESSION
AUGUST 8-10, 2017 - NOVI, MICHIGAN

ACES: A Simulation and Modeling tool for Vehicle Corrosion

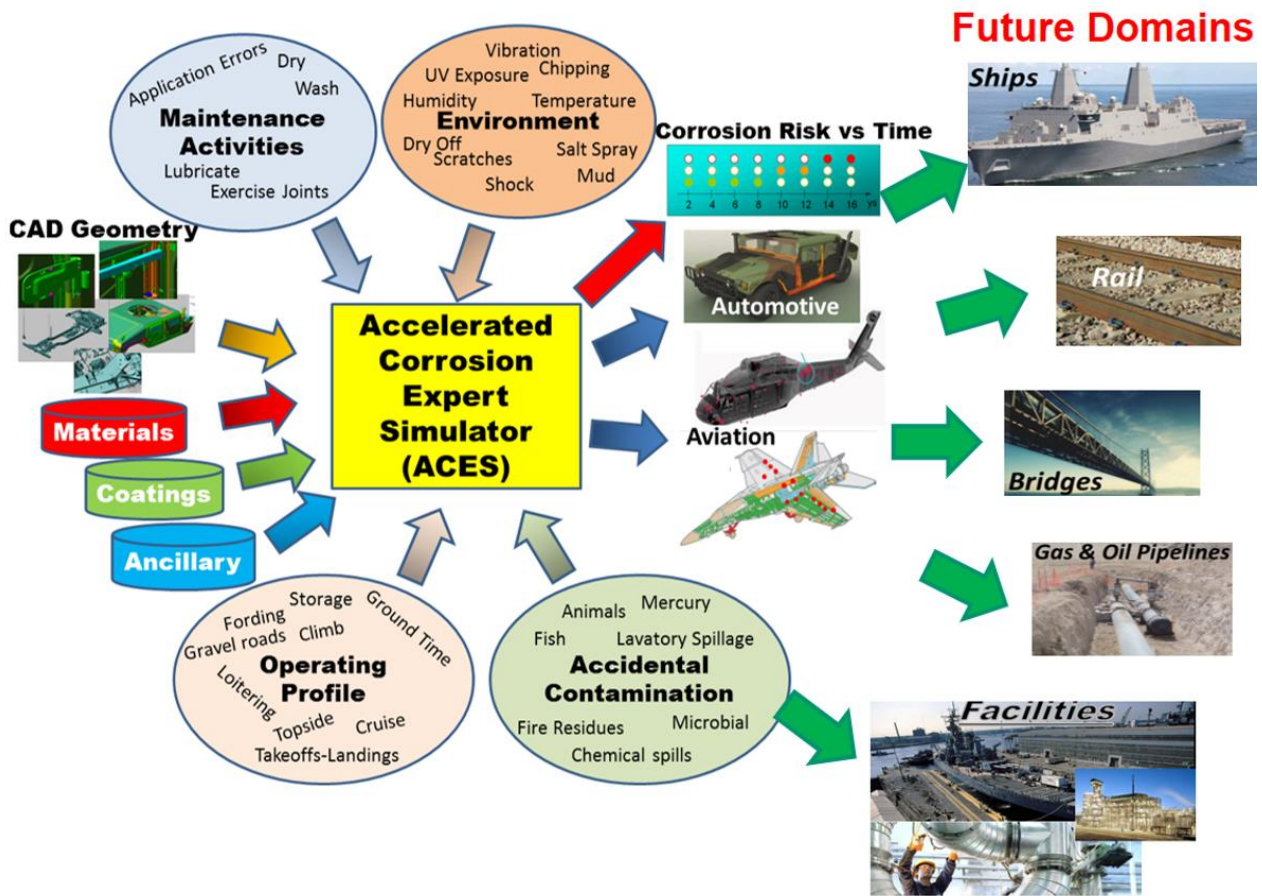
Figure 1: ACES Overview

The US Army TACOM contracted GCAS, Incorporated to produce a complete vehicle simulation and modeling tool called "ACES" (Accelerated Corrosion Expert Simulator) shown in Figure 1 that has a high degree of correlation to an actual full vehicle accelerated corrosion test. The software development contract was initially a Small Business Innovative Research (SBIR) award but is continuing to be enhanced under other contract instruments.

The ACES system imports existing 3-D geometric CAD models of full vehicles using STEP (ISO 10303) AP214 (Automotive) format, along with part substrate material, coating and other ancillary information. A Software Wizard guides the user through adding fastener and bonding (welds, rivets, etc.) as well as additional coating system detail (i.e., multi-layers, coating at assembly level, etc.), as necessary. Geometry related features such as crevices, areas for poultrice entrapment and location of drainage problems are identified for use by the corrosion/coating deterioration algorithms. Vehicle Operating Profiles, Environment and Maintenance Profiles are also defined by the user for use in the vehicle life simulation.

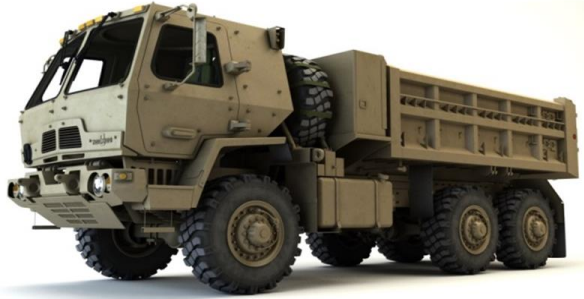
Figure 2: FMTV 5-Ton Truck with MHE

The original algorithms were correlated using Accelerated Corrosion Deterioration Road Test (ACDRT) data provided by the US Army on their FMTV (Family of Medium Tactical Vehicles) trucks [9] shown in Figure 2. The FMTV is primarily a steel vehicle with some Aluminum parts. Both CARC and e-Coat coating

systems are used as the first line of defense in preventing corrosion.

There have been three ACDRT tests performed on the FMTV design. The first ACDRT was a “10-year test” conducted in 1995 at Transportation Research Center (TRC) on the proposed vehicle prototype provided by the original bidder, Steward and Stevenson (S&S). S&S acquired the design from a European company and the “10-year-test” was intended to qualify the corrosion integrity of the design prior to procurement by the Army. The design was found to have several corrosion issues, including the T-handle door assembly discussed more fully below. S&S addressed each of the Army’s corrosion associated concerns, and testing of the redesigned vehicle was performed at the Army’s Aberdeen Test Center (ATC) during the 1998 to 2000 time-period. This testing included “22-year-test” of two M1078 model vehicles, one treated with Carwell rust inhibitor and one “as-produced” by S&S. A third ACDRT was also conducted at ATC as part of the vehicle “re-buy”, which eventually was manufactured by Oshkosh Defense. This third ACDRT is the source of the most reliable test results used for calibration, as discussed below.

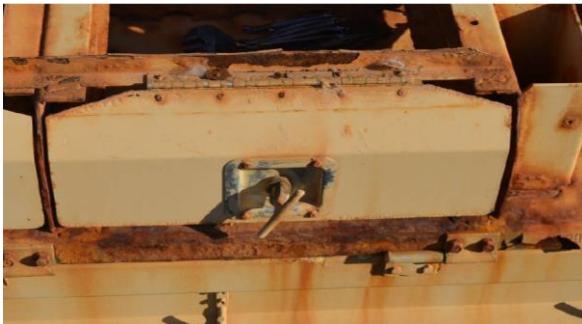
Figure 9: FMTV Stowage Door at the End of 22-year-Test

Figures 8 and 9 show the ACES finite element model of the full door assembly and a photograph of the assembly at the end of the 22-year ACDRT. The T-handle assembly held up very well and, in general, the door assembly fared better than the adjoining mounting rails. One concern was the lack of paint adhesion on the SS dish, indicating that pre-treatment is required.

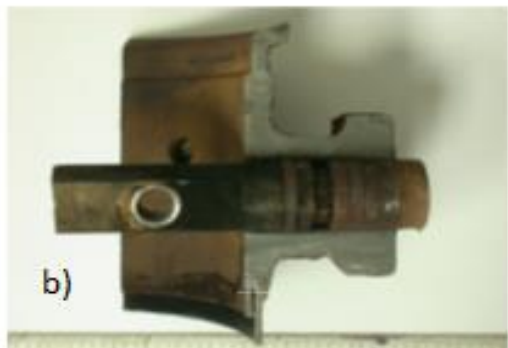
Figure 11: Dissected Butterfly Valve Shaft

Testing indicated that seizure of the butterfly valve shaft in the pillow block resulted in the failure of this Part. The engine exhaust brake was sectioned and disassembled to permit an examination of the internal butterfly valve shaft as shown in Figure 11. The shaft is in the as-received position as shown and is immovable. The shaft is supported in a blind hole on one end (left) and in a pillow block on the other end (right).

The outboard split seal ring shown in Figure 11b above is shown at higher magnification in Figure 12a. The seal is adhered to the valve shaft and a significant amount of corrosion products are present adjacent to the split seal ring in the groove of the mating pillow block as seen in Figure 12b.

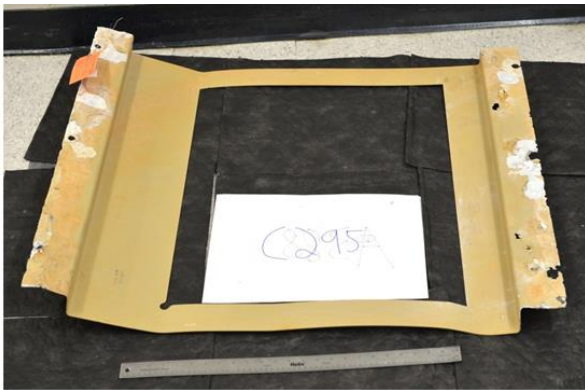
Figure 16: Aux. Trans. Cooler Shroud after ACDRT.

The Auxiliary Transmission Cooler Shroud (Part #12424551) experienced severe galvanic and poulitce corrosion of aluminum shroud as shown in Figure 16.

The crevice corrosion was so severe that it ate through the metal at the bolt attachments as shown by the right side of Figure 16. The crevice corrosion was intensified by the collection of electrolyte at the mating face between the shroud and the frame rails which acted as a water trap as seen by the red arrow in Figure 17.

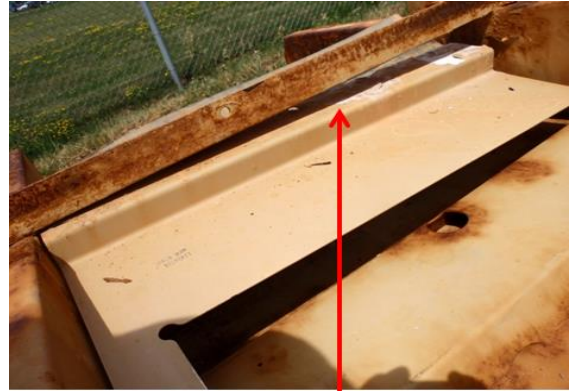
Figure 17: Location of Water Trap associated with the FMTV Auxiliary Transmission Cooler Shroud.

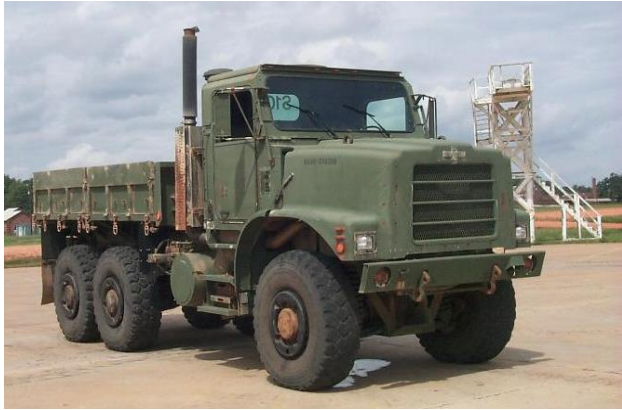
Figure 21: MTVR

An Office of the Secretary of Defense (OSD) demonstration project was awarded to the US Army TARDEC to demonstrate the predictive capability of ACES on the MTRV vehicle over time. The MTRV (Medium Tactical Vehicle Replacement) shown in Figure 21 is a USMC vehicle designed to replace the 5-ton truck (Army M939/ USMC M809). The vehicle was designed and built by Oshkosh Corporation, which, unlike the

FMTV, retained the vehicle drawing package and other intellectual property associated with the vehicle. This situation was advantageous to the validation process in that a third-party company from the software developer, namely Oshkosh Corporation, was contracted to perform the validation and this increases the tool credibility.

The MTVR has undergone three ACDRTs: the original test during procurement at ATC [12], a second test at ATC under ONR contract, and a test at NTC under ONR contract. Unfortunately, all the data and records from the two ONR tests were either lost or destroyed but the original 22-year ACDRT procurement data, including the vehicle that underwent testing were still available for review.

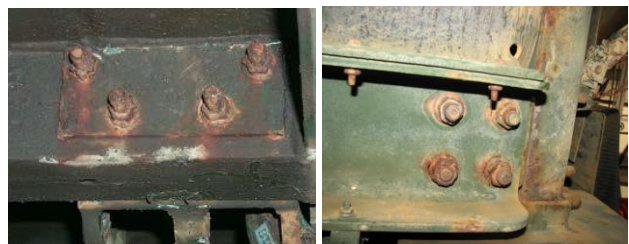
Figure 28: MTRV Truck Frame Fastener Corrosion

The truck frame, particularly around fasteners, has repeatedly been identified as a prime target area as shown in Figure 28.

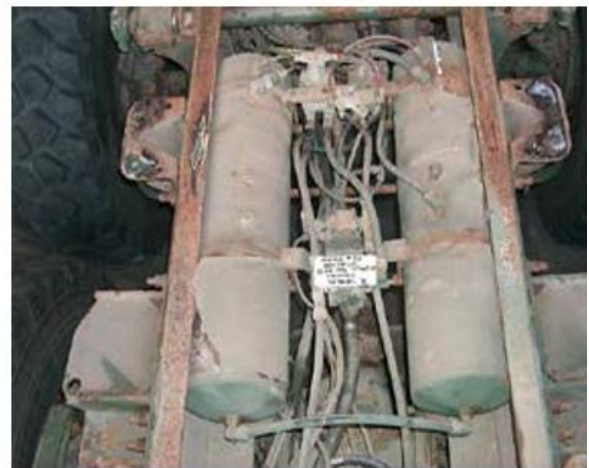
Figure 32: MTRV Air Tank Assembly a) ACES Model and b) ACDRT Result

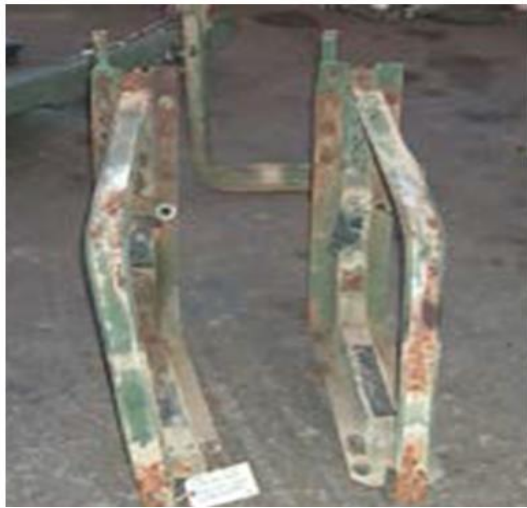
Figure 34: Corrosion of the MTRV Fuel Tank Straps

The analysis of the Fuel Tank Assembly using the original version 1.2 showed immediate fastener corrosion (Figure 33). The main interest of analysis was the deterioration of both of the tank restraining straps observed during ACDRT as seen in Figure 34.

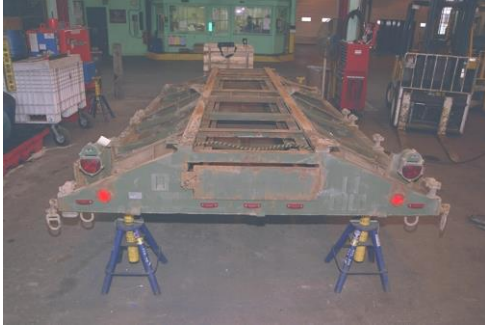
Figure 42: Coating Deterioration on the MTRV Truck Bed Frame during ACDRT

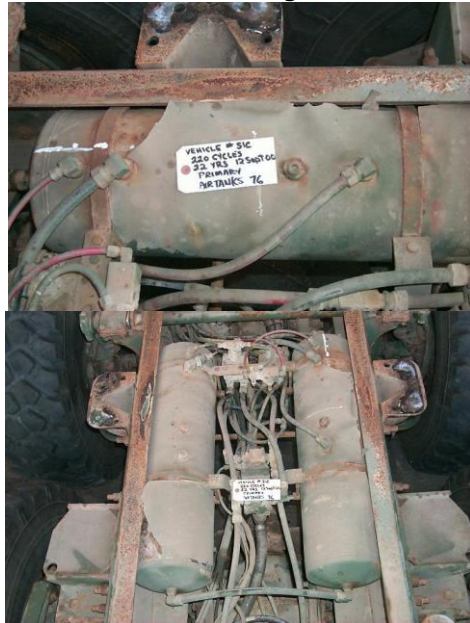
Figure 43: MTRV Air Tanks and Frame Coating Deterioration during ACDRT

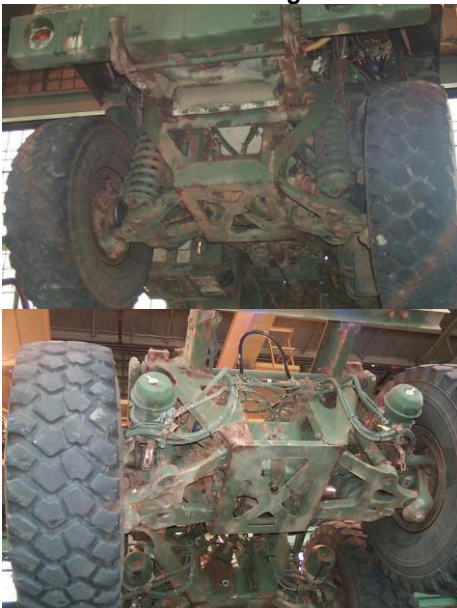
Figure 44: Underbody Suspension Coating Deterioration during ACDRT

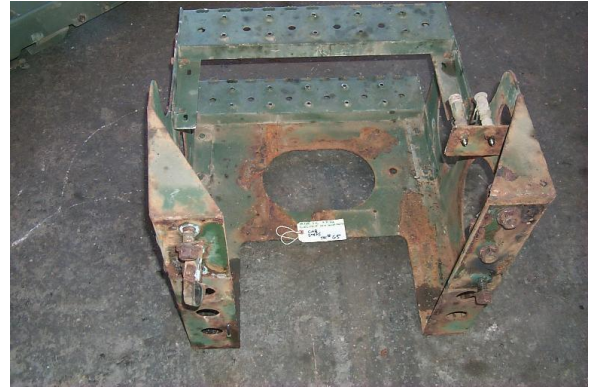
Figure 45: MTRV Mounting Ladder Coating Deterioration during ACDRT
