**2019 NDIA GROUND VEHICLE SYSTEMS ENGINEERING AND TECHNOLOGY
SYMPOSIUM
MSTV TECHNICAL SESSION
AUGUST 13-15, 2019 - Novi, Michigan**

Rapid Capture of Topography for Mobility and Situation Awareness

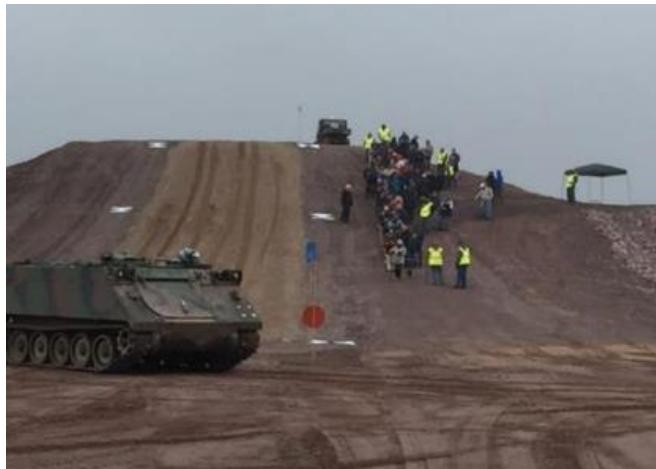
Figure 1: Photograph taken from the bottom of the variable hill climb at Keweenaw Research Center during NATO AVT-308.

at KRC is 60 meters long, 7 meters wide and 8 meters in overall elevation change from base to top. The slope of the grade ranges from 0 to 30% in 5 degree increments every 10 meters (Figure 1). It is filled with a medium, poorly graded sand (SP), as classified by Unified Soil Classification System [1]. This is natural sand, referred to as 2NS [2]. The distribution of grain sizes was measured at KRC, using ASTM International D6913 / D6913M soil sieve analysis standard. Results from three separate samples are plotted in Figure 2.

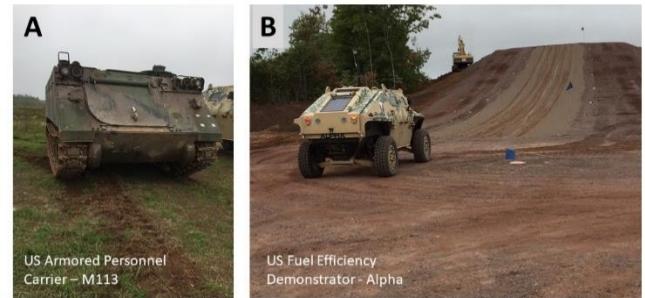
Figure 3: The M-113 (A) and FED-A (B) used for the demonstration.

At left, the M113 is a fully tracked armored personnel carrier developed by Food Machinery Corp. At right, the FED ALPHA by Ricardo is part of the Fuel Efficient Ground Vehicle Demonstrator (FED) program by the U.S. Army's Tank Automotive Research, Development and Engineering Center (TARDEC).

Two vehicles traversed the variable hill climb during the NATO AVT-308 exercise: a US Armored Personnel Carrier M113, and a US Fuel Efficiency Demonstrator Alpha (FED-A). Both vehicles attempted to traverse the variable hill climb, climbing from the bottom, and then traversing down the hill from the top. The FED-A was operated at a speed, which was too low on the traverse up the variable hill climb, and did not climb all the way (Figure 3).

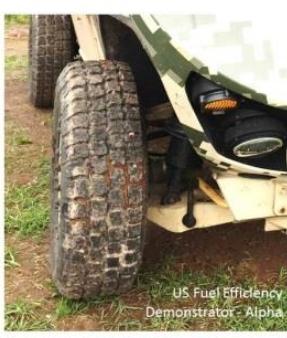
At left, the FED-A tread is shown on the vehicle and its impressions are recognizable in the reconstructed terrain models captured by the UAS collection system shown at right (Figure 5).

Figure 5: Detail of the FED-A tire pattern and soil impression.

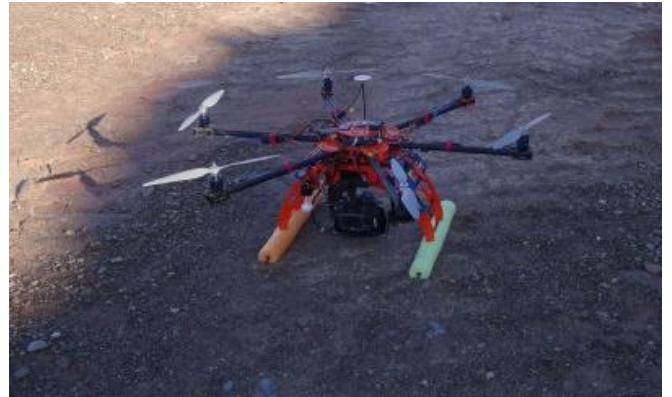
Data collections were conducted using a Bergen Hexacopter with a Nikon D810 camera payload (Figure 6). The Bergen Hexacopter is capable of carrying up to 2.3 kg of payload with a flight time of up to 16 minutes. The camera is mounted to a 2-axis gimbal to compensate for roll and pitch of the drone. The gimbal also allows for the camera to be pointed at any angle from 0-90 degrees (looking forward to nadir) depending on data collection requirements [3].

Figure 6: Bergen Hexacopter with a Nikon D810 ready for deployment.

The Nikon D810 camera has a 36.3 MP sensor which provides high resolution imagery when collected from a drone. The resolution of the imagery approximately 5 mm is achieved from a flying altitude of 30 m. Collecting sufficient imagery overlap is crucial for the accurate reconstruction using Structure from Motion (SfM) [4]. This is achieved by flying at a maximum speed of 2 meters per second. At the speed, a single point on the ground is represented in at least five images.

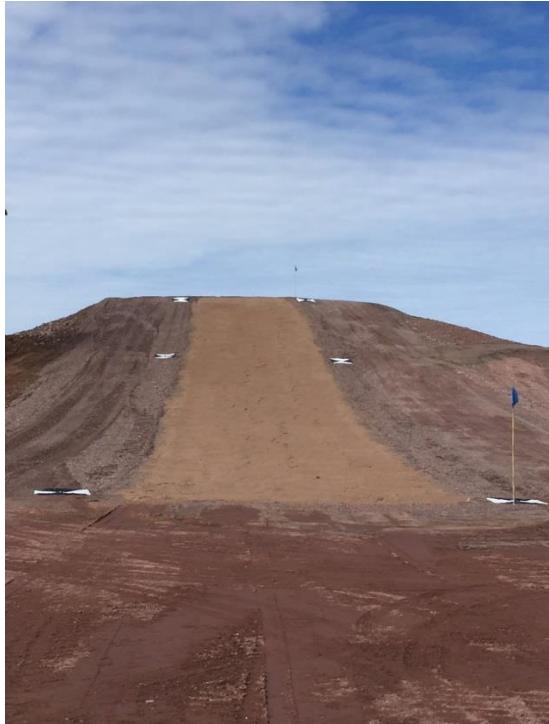
As shown in Figure 7, ground control targets were placed along the sides of the variable hill climb for improved georeferencing of the 3D models. This also reduces scaling errors in the 3D reconstruction and improves change detection comparisons between 3D models from separate collects. Six traditional 1m x 1m black and white ground control targets were used, one in each and one on either side of the center of the variable hill climb. GPS positions were collected using a Trimble GPS with decimeter level accuracy. GPS data was used by the SfM software for the reconstruction of the 3D models and the out.

Figure 7: Data collections were conducted on the variable grade hill at KRC.
