**2019 NDIA GROUND VEHICLE SYSTEMS ENGINEERING AND TECHNOLOGY
SYMPOSIUM
< MATERIALS & ADVANCED MANUFACTURING (M&AM) > TECHNICAL SESSION
AUGUST 13-15, 2019 - NOVI, MICHIGAN**

**Test the Corrosion Effect on High Hard Steel Armor MIL-DTL-46100
Coated with Stellite 6 Applied by Direct Energy Deposition Method**

ABSTRACT

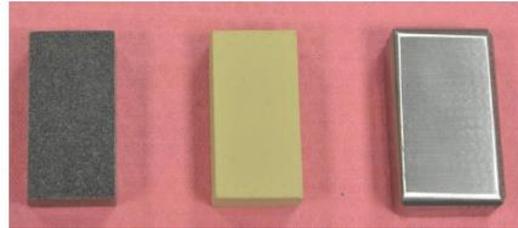
Figure 1. Image of the uncoated, primer-CARC, and DED coated test coupons.

The base coupons were made out of a half inch thick high hard steel armor (MIL-DTL-46100) plate. Surface hardness of this material is between 49-54 HRC (477 and 534 BHN). This study consisted of a total of 75 test coupons. Each coupon was rectangle shaped, sized 25.4 mm by 50.8 mm by 13mm of which: 25 pieces remained bare uncoated metal, 25 pieces covered with a MIL-DTL-64159-Type 2 CARC paint and zinc rich primer coating, and 25 pieces covered with a two layer coating of Stellite 6 powder. The coupons were placed in the GVSC Fuels & Lubricants Laboratory salt fog spray chamber for 24 weeks. The percent salinity was maintained within the range of 4.5 to 5.4, and pH of the chamber ranged from 6.7 to 7.1. A single coupon of each type was

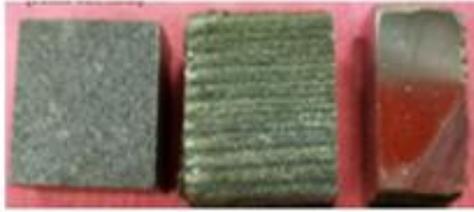
Figure 3. The before and after image of an uncoated and coated coupon can be seen in this image.

The DED coating for the HH coupons were produced with the DM3D 405D deposition system. The Stellite 6 was applied in a powder form, with a particle size range of 30 to 150 microns. The powder was preheated with an open atmosphere oven at 400 degrees Fahrenheit, for 10 minutes, before being loaded into the DM3D powder hopper. The powder was delivered to the substrate during the DED process through the use of a grade 5 argon gas flow system. The first layer used a powder flow rate of 28.4 g/min and a laser power input of 2 kW. The second layer used a flow rate of 17.7 g/min and an input of 1 kW. The head movement speed for was 880 mm/min for the first layer and 340 mm/min for the second layer. The two layers were completed in an alternating transverse-longitudinal pattern with a 2 mm laser spot size, and a 1.25 mm offset from the center of the beam for each overlapping pass, in each layer. The DED process was conducted in an open air environment, with a shield gas provided in addition to the powder carrier gas to protect the melt pool during deposition. A cross section of the unfinished deposition can be seen in Figure 3 below. Each side of the coupons were designated, as seen in the right side of Table III.

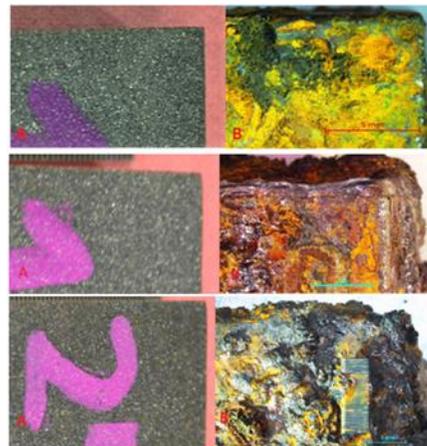
Figure 4. Uncoated substrate specimens.

As can be seen from Figures 4, 5, and 6, the development of corrosion on the coupon surfaces can be seen in weekly order of 1, 12, and 24, from top to bottom. The unprotected surfaces (side 1) of each specimen type demonstrated consistent progression of corrosion build up in equal measure. The corrosion resistance of the painted coupon were comparatively superior to the uncoated coupons. However, indications of pitting under the front painted surfaces of side 6 were noted in the week 8. The front surface (side 6) of the painted coupons began demonstrated considerable pitting around week 9. Also during week 9, the interfacing edges of the primer-CARC and substrate on side 1 began demonstrating a progressive increase in corrosion incursion.
