**2015 NDIA GROUND VEHICLE SYSTEMS ENGINEERING AND TECHNOLOGY SYMPOSIUM
MODELING & SIMULATION, TESTING AND VALIDATION (MSTV) TECHNICAL SESSION
AUGUST 4-6, 2015 – NOVI, MICHIGAN**

**INTERIOR HEAD IMPACT PROTECTIVE COMPONENTS AND MATERIALS FOR
USE IN US ARMY VEHICLES**

**Julie Klima
Rebecca Marquardt**
Ground Systems Survivability
TARDEC
Warren, MI

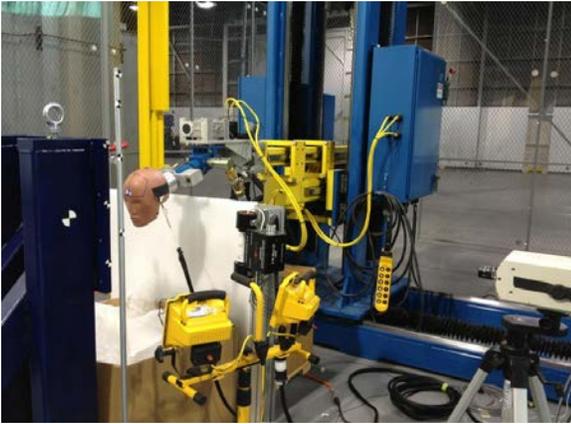
TARDEC utilized the Soldier System Interface Impactor Laboratory located at Selfridge Air National Guard Base, Harrison Township, Michigan (SANG SSII) to conduct head impact testing, Figure 1. The SANG SSII is equipped with head impact test equipment consistent with the FMVSS 201U standard using a Free Motion Headform.

Figure 1: Head impact fixture

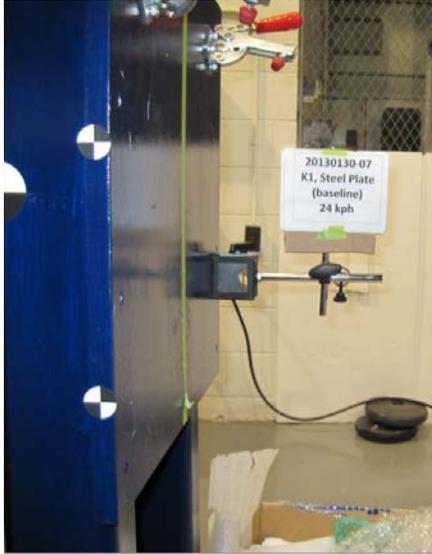
TARDEC tested different COTS energy attenuating (EA) core materials at the SANG SSII laboratory using a rigid flat fixture, Figure 2. The core material requires an additional layer of protection for durability. The additional durable layer of material is referred to by TARDEC as an exposed surface sheet. Each core material was tested with a different durable exposed surface sheet to understand the effects the exposed surface sheet had on the energy attenuation characterizes of the core materials.

Figure 2: Rigid Flat Fixture
